**ART** calls on all BlackBird owners to replace the **upper bearing pin of the friction enhancer** along with the corresponding screw.

### **“Nose” – Right Side Plate of the Friction Enhancer**

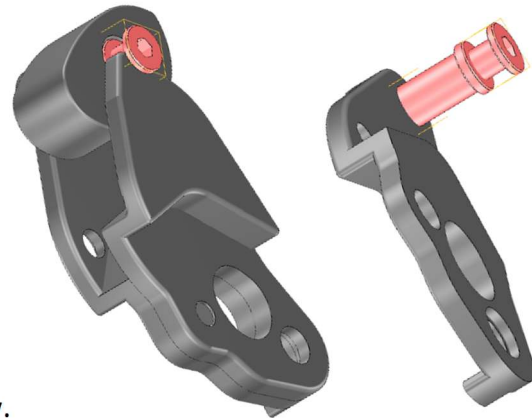
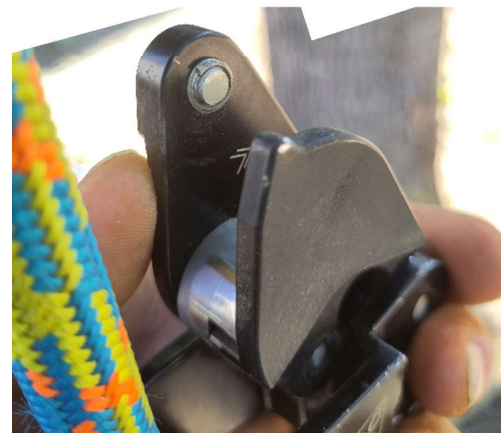
During inspections, we have identified isolated cases of variations in the material strength of the upper bearing pin. These variations could lead to a pin fracture and, consequently, failure of the upper clamping jaw. There is no immediate risk of a fall, as the remaining clamping jaw inside the BlackBird's body maintains reliable clamping even if the upper bearing pin were to break.

The required replacement kit (including instructions) will be provided free of charge and will be available from calendar week 45. The new pin features a significantly increased wall thickness, and the corresponding screw engages much deeper into the pin; the thread is now positioned in the rear section of the pin to provide greater overall strength.

Nevertheless, we ask that you carry out the replacement promptly, as we currently lack long-term data for this scenario.

To request the replacement kit, please email us: [info@climb-art.de](mailto:info@climb-art.de)

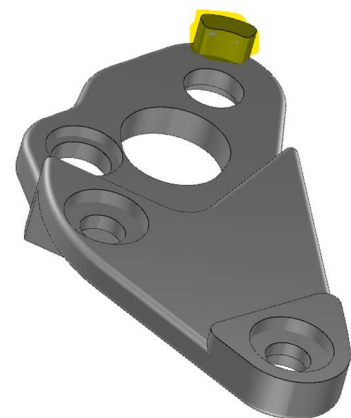
A few climbers have also informed us that the “nose” on the friction enhancer has broken off. The nose stop is designed to regulate the clamping movement of the friction enhancer.

If the nose breaks, the friction enhancer can extend fully, causing the entire system to lock up. There is no risk of a fall in this situation.

We have already reinforced this area with two stainless-steel pins, but this measure alone is not sufficient to completely prevent the shearing of the nose.

To address this issue as well, we have decided to manufacture the right side plate of the friction enhancer, and thus the “nose,” from stainless steel. This significantly increases the material strength and greatly enhances the overall robustness of the BlackBird. At the same time, we have optimized the contours to limit the weight increase to only 40 grams.

You may choose whether to have the side plate replaced as a precautionary measure or only in the event of a damaged “nose.” The replacement is **free of charge** and must be carried out at ART’s facility. We expect to be able to perform the full replacements starting in calendar week 49 and will begin accepting your returns from week 48.
