ART calls on all BlackBird owners to replace the **upper bearing pin of the friction enhancer** along with the corresponding screw.

“Nose” – Right Side Plate of the Friction Enhancer

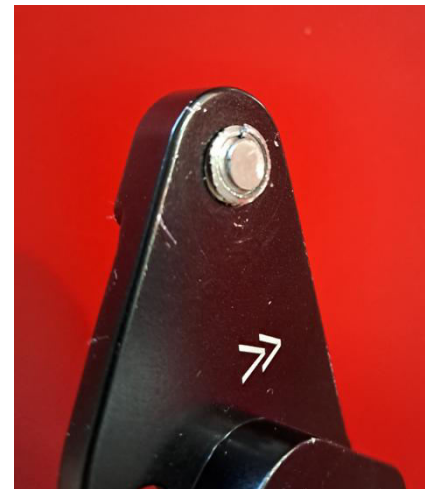
During inspections, we have identified isolated cases of variations in the material strength of the upper bearing pin. These variations could lead to a pin fracture and, consequently, failure of the upper clamping jaw. There is no immediate risk of a fall, as the remaining clamping jaw inside the BlackBird's body maintains reliable clamping even if the upper bearing pin were to break.

The required replacement kit (including instructions) will be provided free of charge and will be available from calendar week 45. The new pin features a significantly increased wall thickness, and the corresponding screw engages much deeper into the pin; the thread is now positioned in the rear section of the pin to provide greater overall strength.

Nevertheless, we ask that you carry out the replacement promptly, as we currently lack long-term data for this scenario.

To request the replacement kit, please email us: info@climb-art.de

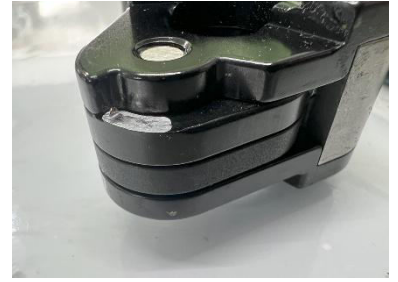
The BlackBird is certified by **TÜV Süd** in accordance with **EN 12841** and has successfully passed numerous tensile tests without any issues. The breakage of the “nose” described here occurred exclusively during use in SRT (Single Rope Technique) and in combination with a resin-contaminated rope.

When used with such a rope, the friction enhancer may temporarily seize. If the release lever is then fully actuated, the enhancer can suddenly extend, transferring a sharp impact force directly onto the small “nose”, which may shear off as a result.

To address this issue as well, we have decided to manufacture the right side plate of the friction enhancer, and thus the “nose,” from stainless steel. This significantly increases the material strength and greatly enhances the overall robustness of the BlackBird. At the same time, we have optimized the contours to limit the weight increase to only 40 grams.
