RP048 – RP057 replacement parts instructions

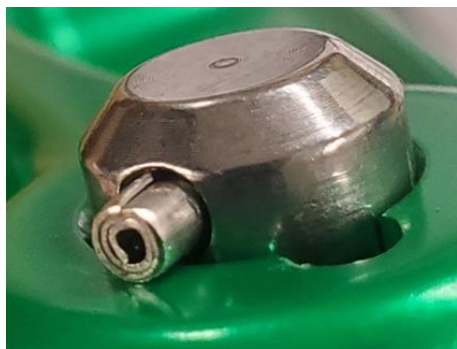
8. The coil of the Spirol/scroll pin MUST face away from the frame to prevent it catching and scraping (see attached image);
9. Check the function of the locking pin

6. The axle will need to remain under tension away from the top bollard to fit the replacement Spirol/scroll pin;
7. Fit the Spirol/scroll pin to axle so that the pin just clears the channel through the frame (RP048 - 2.5mm, Others – 3mm), but gives the maximum purchase in safe position recess;
